Inspection of CLS Facilities equipped with Oxygen Depletion Monitors

Jan/Feb 2011

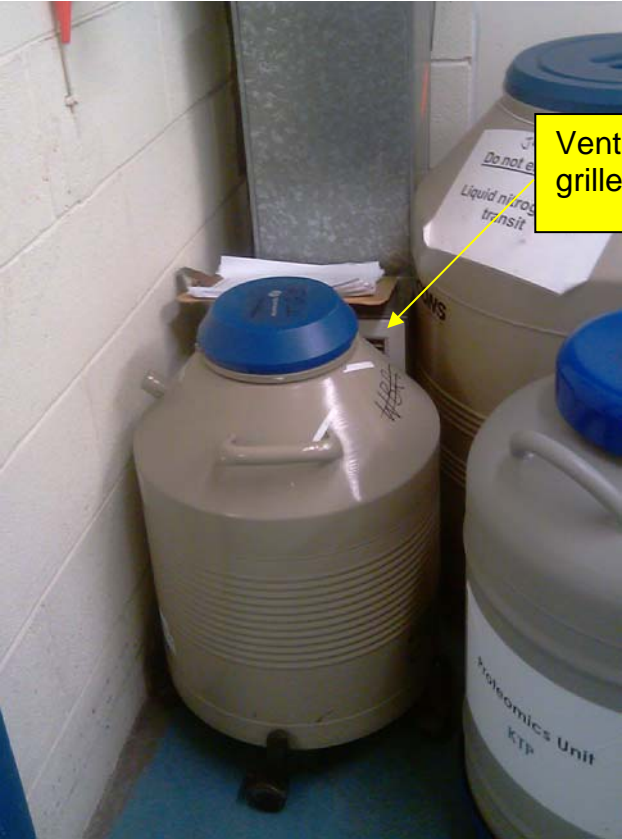
Photo 1

- i. Facility Managers will be reminded to report faulty repeater units immediately by email to LG.
 - ii. LG to arrange for E&B/CLS Workshop to attempt repairs in the first instance and call upon Quantum only if the problem cannot be rectified in-house.
-
4. The 2003 inspection report highlighted the inadequate ventilation in the WTB LN₂ Dispensing room and the H&SWG have raised this on a number of occasions since but no remedial action has been taken. The problem is compounded by the current low level extract system being frequently obstructed by LN₂ tanks (see photo 1 in the appendix). The CLS E&B Liaison Officer/Building Coordinator was to

- i. College Secretary and Stores Manager to discuss and formally respond with an action plan.

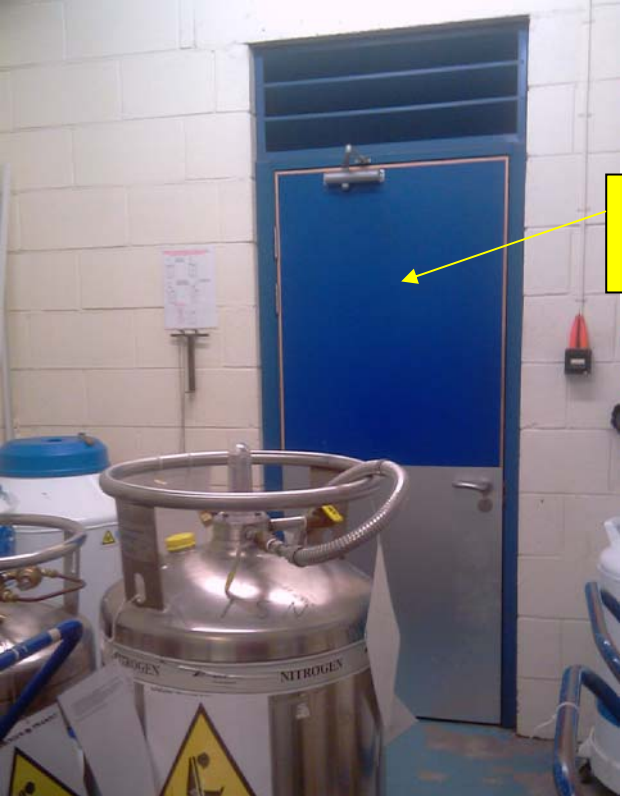
Photo 2

look into getting an additional extract fan installed in the door leading from the dispensing room to the supply tanks (photo 2) but this was never progressed. In addition to inadequate ventilation:

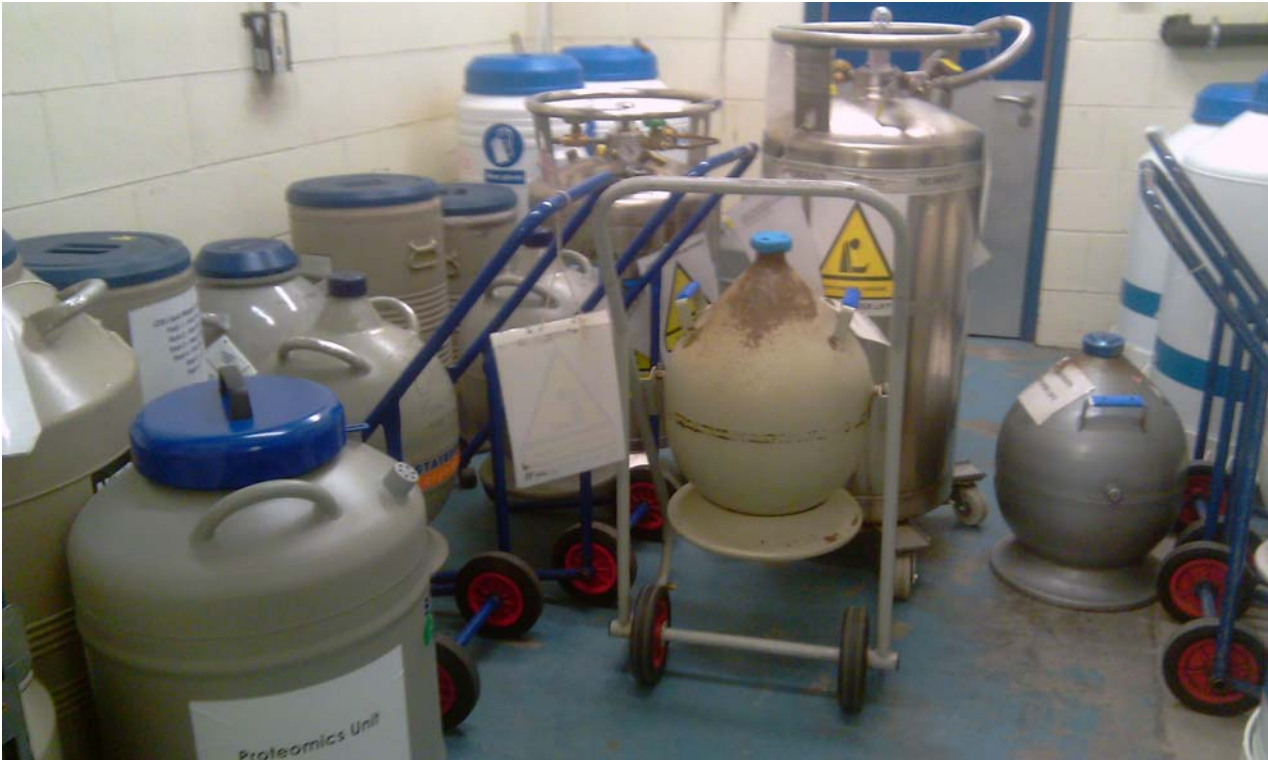
Photo 3

- At the time of the inspection the room was overcrowded with LN2 vessels (photo 3).
- The PPE Inspection Record was last filled in on 13/6/2005.
- The two most recent employees have not signed the risk assessment signature sheet.

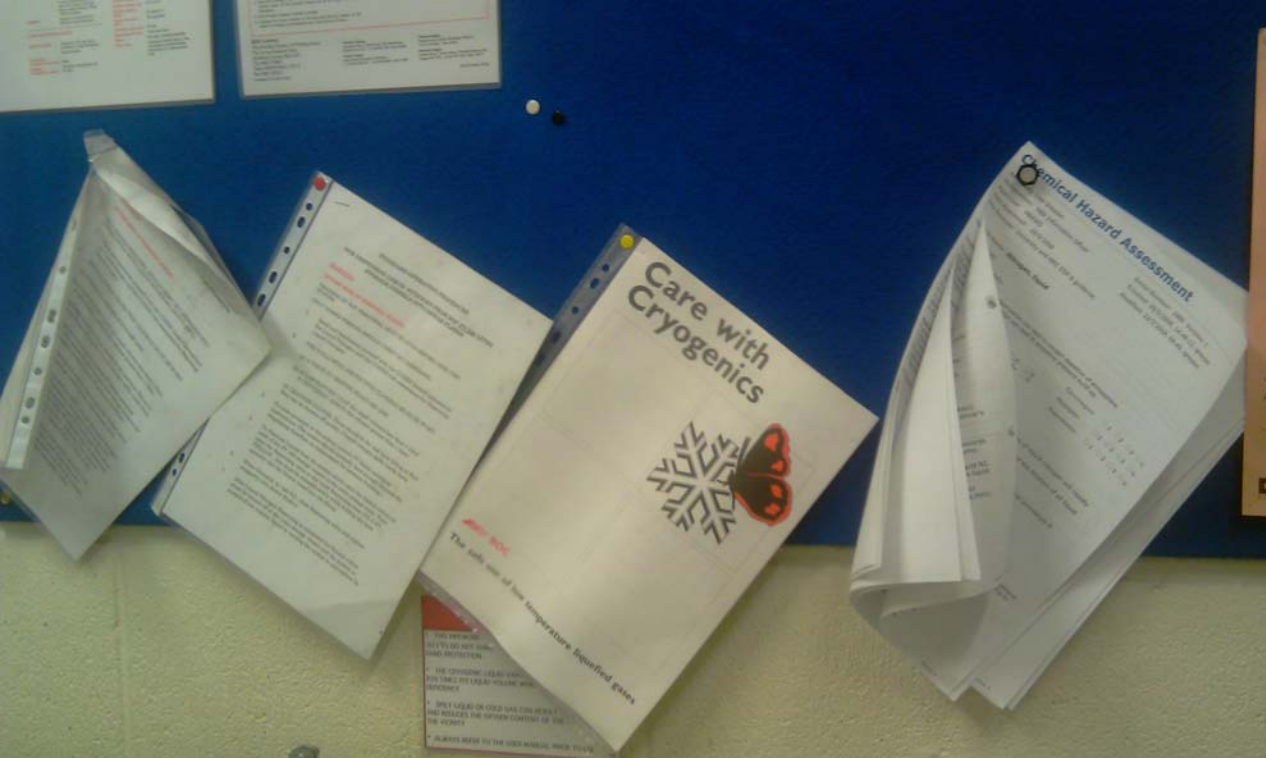
Photo 5

- The old safety folder is still present and full of outdated documentation.
- The safety documentation pinned to the notice board needs to be renewed (photo 5).
