# General H&S Inspection Checklist

Area being inspected: MSI 3<sup>rd</sup> Floor

Date of Inspection: 10/3/2010

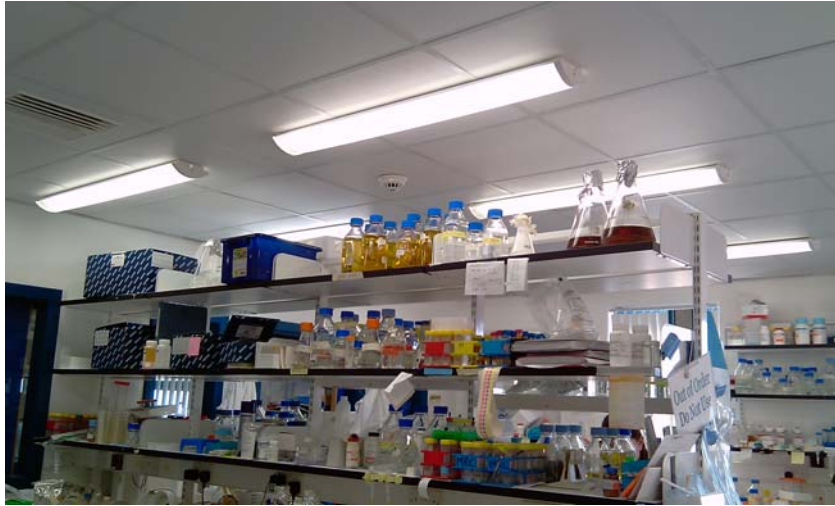
Photo 1: DVA Lab

- Are any items stored at height? [Yes](#)
  - If yes, any obvious unsafe storage? [Some glass bottles/flasks stored at height\\*](#)
  - If yes, is a step ladder or kickstool available? [Kickstool is available](#)
- Is the main chemical storage area clean & tidy? [Yes](#)
- Are stocks of flammables kept in flame-proof cabinets? [Yes](#)
- Are incompatibles kept separate? [See below](#)
- Are highly dangerous substances\* kept in a locked store? [See below](#)  
(\*highly dangerous substances: as defined in Safety Services policy.)
- Notes:

[\\*See photo 1 on page 5. Consider reorganising shelves.](#)

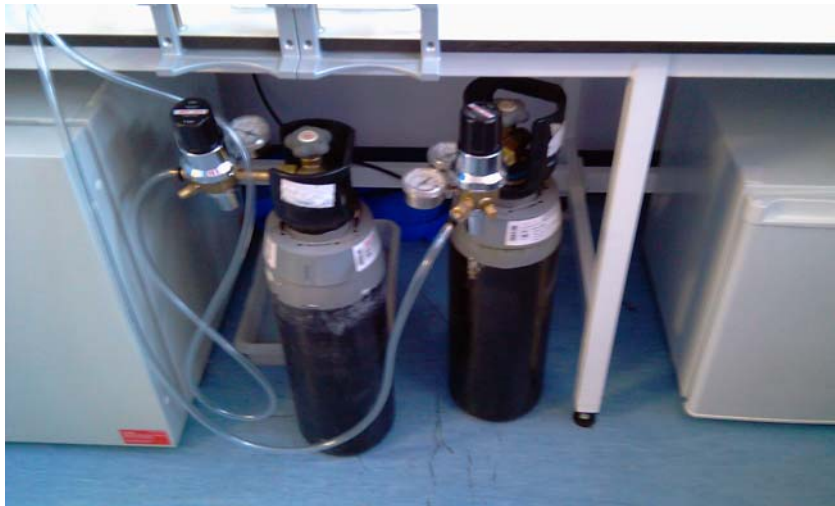
Photo 2: KGS Lab, Room 3.33

There are two CO<sub>2</sub> cylinders in the KGS lab area, in room 3.33. Neither cylinder is properly restrained – see photo 2 on page 5. Lab Manager to rectify. Regulators are in date.
