General H&S Inspection Checklist

Area being inspected: MSI 2nd Floor

Date of Inspection: 24/3/2010

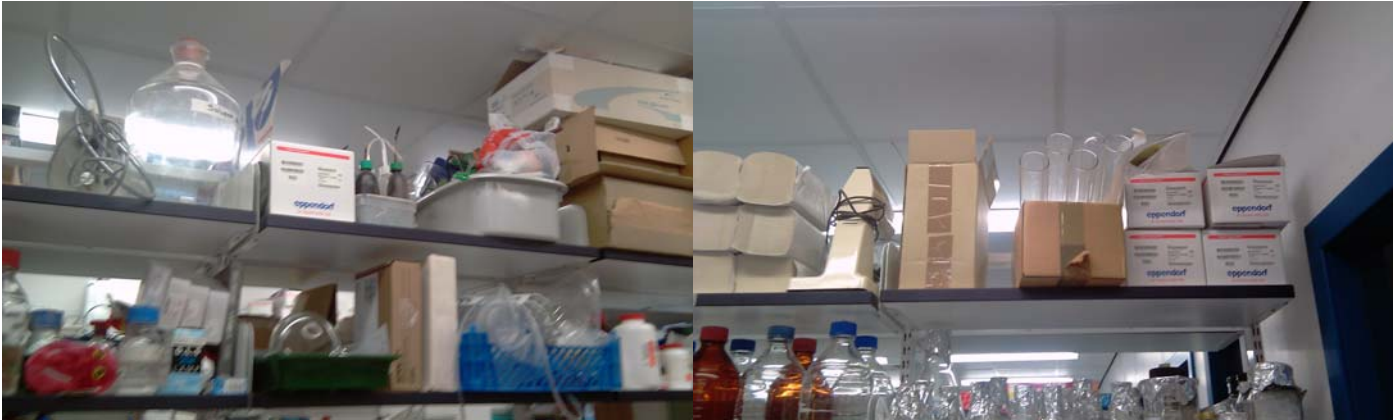
- Are any items stored at height? [Yes](#)
 - If yes, any obvious unsafe storage? [Some large glass items stored at height*](#)
 - If yes, is a step ladder or kickstool available? [Kickstool is available](#)
- Is the main chemical storage area clean & tidy? [Yes](#)
- Are stocks of flammables kept in flame-proof cabinets? [Yes](#)
- Are incompatibles kept separate? [See below](#)
- Are highly dangerous substances* kept in a locked store? [See below](#)

Photo 1: Item stored at height

[*See photo 1 on page 5. Consider reorganising shelves. Take great care when moving items from the top shelves.](#)

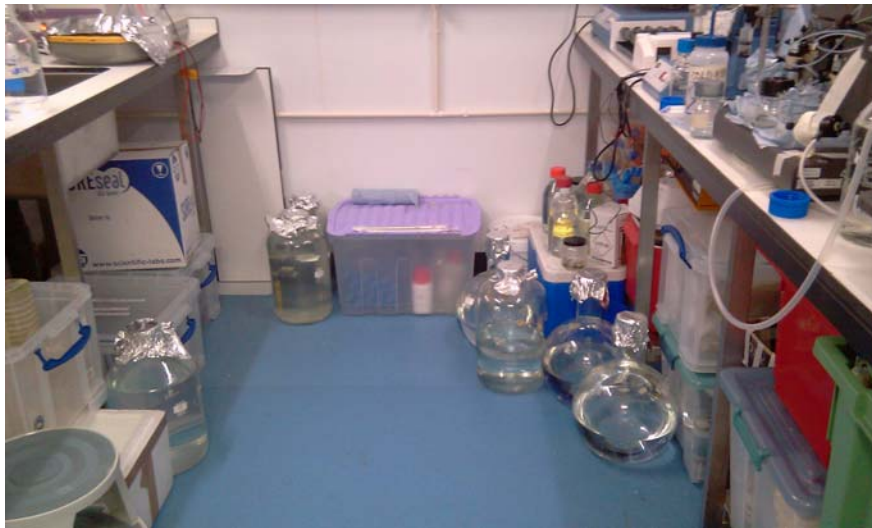
Photo 2: Heavy vessels stored on cold room floor

- Are any unusual manual handling hazards evident? [Yes](#)
 - If yes, are adequate controls in place? [See below](#)
 - Notes:
[See Photo 2 on page 5. At least two of the largest containers were filled with liquid. These will be very heavy and anyone attempting to lift them runs the risk of back and/or upper limb injury. Heavy items should be stored at bench height where they can be moved onto a trolley for transport without any vertical lifting. Consider using smaller vessels.](#)
-

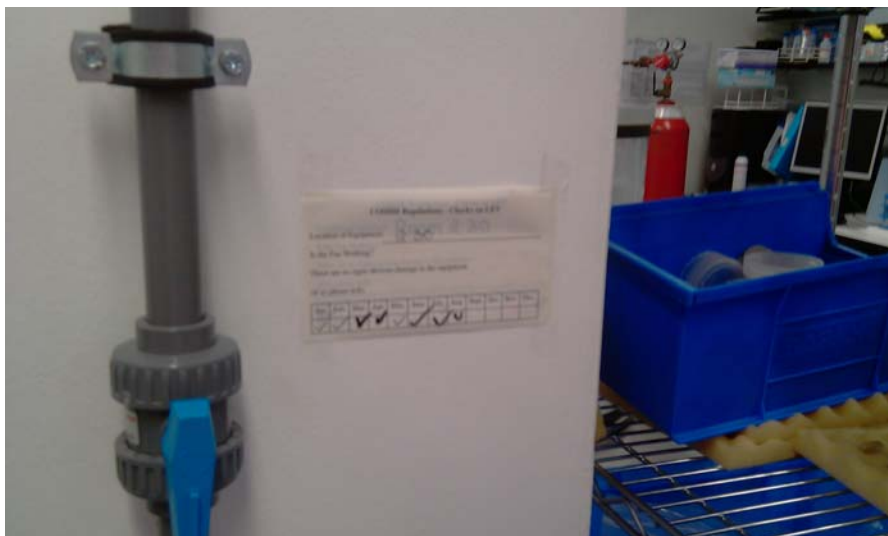
Photo 3: LEV with out of date log sheet

1. There are two out of date ‘checks on LEV’ stickers next to extraction systems in the main equipment room – see Photo 3 on page 5. Lab Manager to confirm if these systems are still being tested, at what frequency and by whom.
2. Used glass pasteurs are being deposited into a beaker by the pH meter – see Photo 4. Consider disposing of them directly into a Sharpsafe to minimise handing of waste sharps and keep them safely contained.
3. There was an SOP posted by the microwave but no heat protective gloves were in evidence at the time of the inspection. Lab Manager to ensure heat protective gloves are available.
4. Some mercury thermometers are in use. These should be phased out and replaced with non-mercury thermometers.

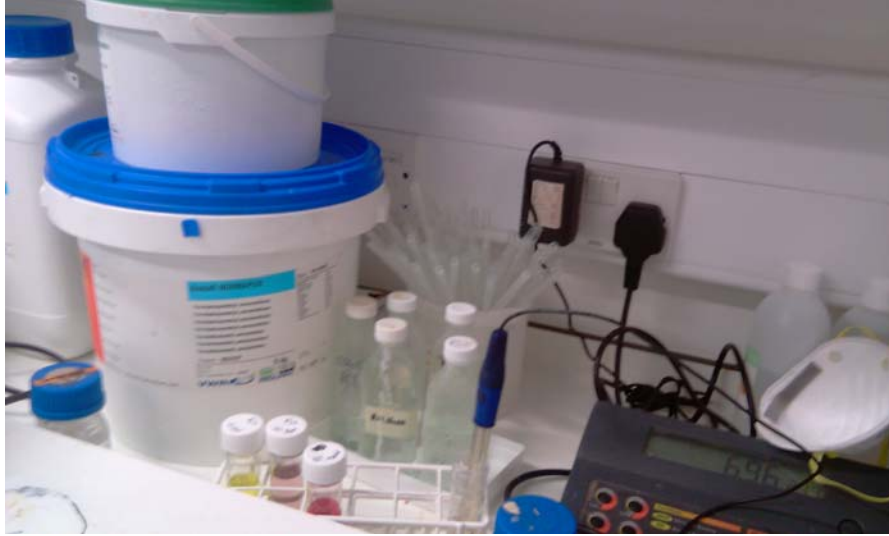
Photo 4: Used sharps in beaker
